IMPACT MARKS ON BATH STONE (JURASSIC OOLITE): WW2 BOMB AND BULLET DAM- AGE ON BUILDINGS IN BATH

By Maurice Tucker
maurice.tucker@bristol.ac.uk

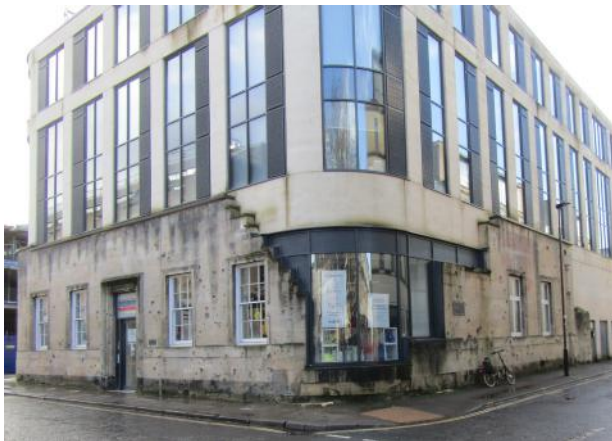
Fig. 1: The former Labour Exchange building, built 1938, repaired 2017, James Street West, Bath, with shrapnel damage in the lower few metres.

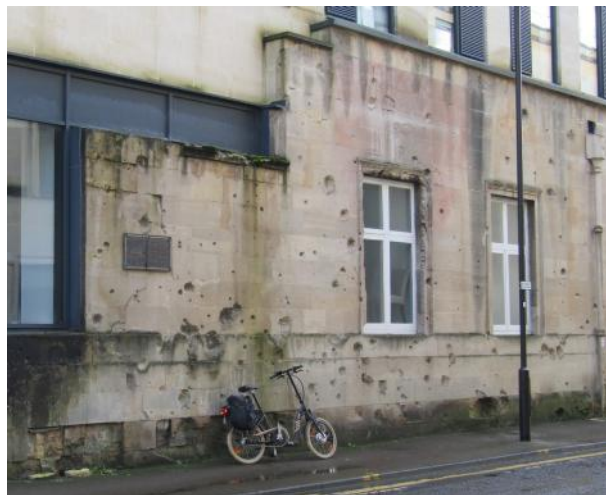
The building is constructed of Bath Stone, as to be expected, which is a well-sorted uniform oolitic grainstone with few bedding or sedimentary features – a good free-stone in other words, possibly from Box-Corsham. The hundreds of impact craters on two sides of the building reach up to 20 cm across and 8 cm deep but there are numerous smaller ones a few cm across (Fig. 2).

Fig. 2: The Labour Exchange, Milk Street side, with bomb damage and pink stone upper right from the effects of fire on higher floors.

The effect of fire on Bath Stone is to turn it a pinkish-red colour. This will be the heat causing oxidation of iron minerals like pyrite (a ferrous iron, Fe^{2+}), turning it into a ferric oxide (Fe^{3+} , like hematite). After the war, historic buildings were repaired where possible but stone that had been involved in a fire was generally not re-used for buildings except locally in the construction of walls. Such pink-red stones can be seen in walls along the north side of Julian Road (Fig. 11), opposite the site of St Andrew's Church. Pink stones can also be seen on the front wall of the historic Abbey Church House (Westgate Buildings), the only domestic survival from the 16th C in Bath. It was near-destroyed, but then rebuilt in 1953 to be more Elizabethan than it was before the war, replacing Georgian sash-windows with lattice case-ments! The higher part of the Labour Exchange wall in Milk Street has many pink stones resulting from the fire that destroyed the upper floors (Fig. 2).

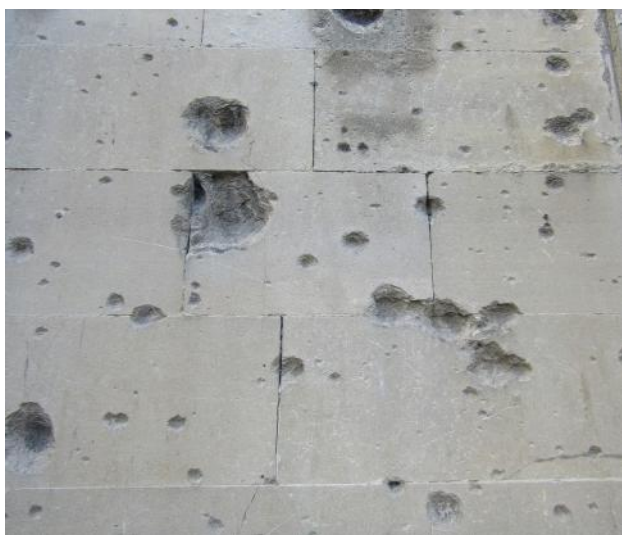
They are mostly near-circular, some more asymmetric. There are some radiating fractures related to the impacts, and in places there are hints of concentric fractures. The stone would seem to have broken off in shards and flakes and been comminuted or pulverised. Some craters are quite smooth in fact, as if the stone at the point of impact was finely broken up and recemented or recrystallised from the shock (Figs. 3, 4).

Fig. 3: Labour Exchange impacts marks, variable size. Size of stone blocks 30 cm high.

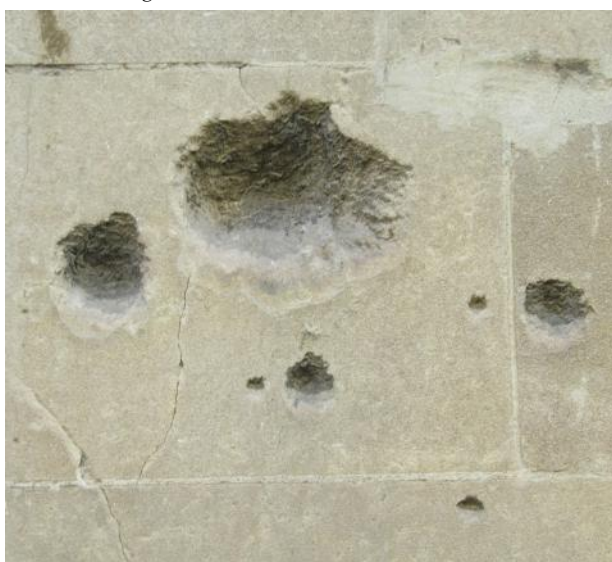
Fig. 4: Labour Exchange impact craters close-up with smooth interior compared with weathered stone.

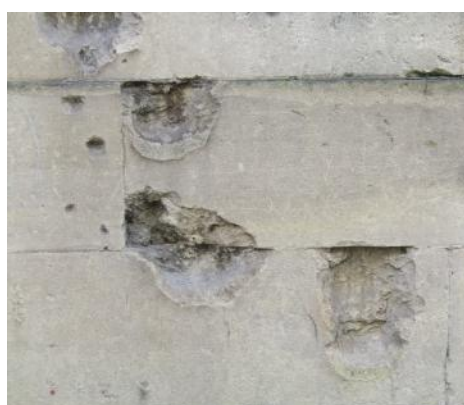
Where an impact struck towards the margin or corner of a stone block and in some cases the crater stopped at the edge of a block, the generally circular shape of the crater did not develop. Rather, the crater has one or two straight sides (Fig. 5). Clearly here the shock was not able to propagate across the boundary between blocks, where there is some mortar, but not always.

Fig. 5: Labour Exchange impact crater shape affected by stone block boundaries.

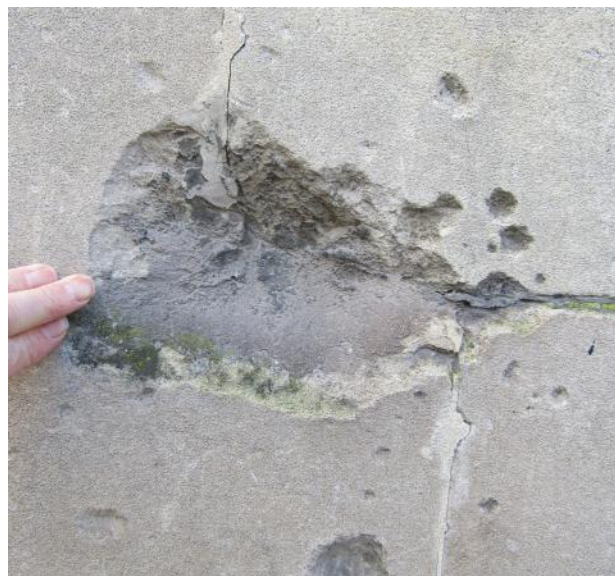
However, in other cases where the crater has developed across two blocks, the boundary itself between the blocks is not visible (Fig. 6). Presumably, this is the result of the shock pulverising the rock and causing its recrystallisation or recementation so that the boundary and mortar disappear. One interesting observation from those witnessing the Blitz is the significant amounts of dust that Bath Stone produced from these ballistic impacts. In fact, not only did carbonate dust cause respiratory problems for people breathing in the pulverised stone, but it also led to infections of open wounds.

Fig. 6: Labour Exchange impact crater across 2 blocks where the boundary has been lost. Note the granular nature of the weathered surface of the limestone, contrasting with the finer-grained nature of the stone within the crater.

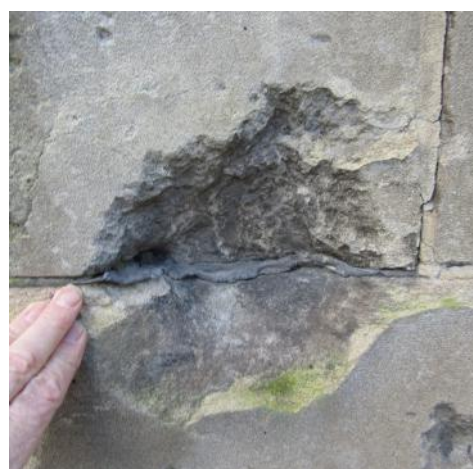
Of further interest there is a lead damp course running across the building's wall at two levels: 40 cm and 1 m above the ground. Where an impact struck near the lead sheet, it has curled up and been deformed (Fig. 7). Indeed, it may possibly have even melted since in some places it seems to have thickened up or even disappeared, vaporised (?) (Fig. 6). This would indicate significant heat generated by the impact as shock metamorphism.

Fig. 7: Labour Exchange impact crater with deformation of the lead damp course

Fig. 7 continued: Black discolouration here and in other figures is likely recent organic-microbial staining.

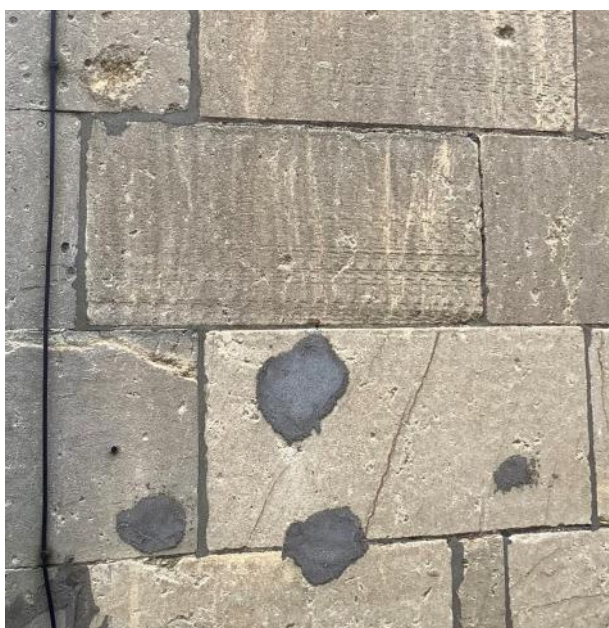
In some places around the city, shrapnel craters on buildings have been filled with a cement to hide them. However, this has met with varying degrees of success depending on how much effort was put into matching the colour and grain-size of the cement to the stone itself. Many filled impact marks can be seen in the curved wall outside the main entrance to Bath Spa railway station (4 bombs landed very close by) and on the north side of Queen Square, where a 500 kg bomb landed in the SE corner destroying 4 houses that were part of the Francis Hotel. Another example can be seen in Third Avenue, Oldfield Park, with an unfilled crater higher up (Fig. 8).

Fig. 8: Four cement-filled impact craters and one empty one higher up on the wall of a house in Third Avenue, Oldfield Park, in the immediate vicinity of a bomb site.

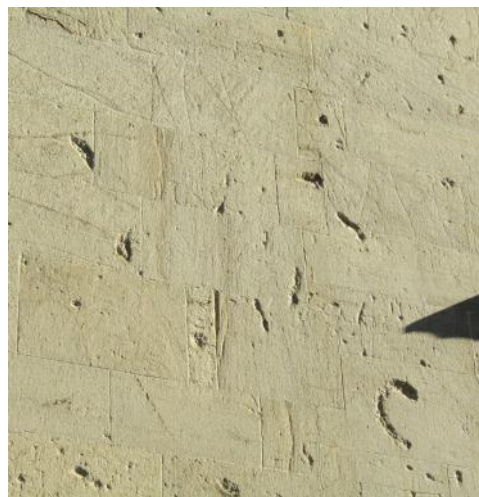
On the walls of some buildings there are 'gouge' marks that are somewhat elongate. In some places, several occur close together and they can have a similar orientation, commonly directed downwards or at an angle (see Figs. 9, 10). They tend to be 10-20 cm in length and 2-5 cm across, 1-2 cm deep. These would appear not to be formed in the same way as the more circular, deeper, shrapnel impact marks, formed by exploding bomb fragments and debris flying out from the impact site, bits of building, road, pavement etc. The shrapnel impact marks tend to occur in the lower parts of building walls, and they get smaller higher up the wall as at the Labour Exchange; the elongate marks tend to be higher up at 1st-2nd floor level. It is suggested then that these elongate features were produced by the machine-gun bullets being fired from the German planes. They can be seen in Queen Square, east side and top of Barton Street close to where a bomb landed, near where a large part of the Francis Hotel was destroyed, and elsewhere, Jane Austen's house and Miles's Buildings.

Fig. 9: Elongate marks possibly from machine-gun bullets, on a wall of Miles's Buildings.

These mini-crater-like structures certainly look like small ballistic impact marks, like someone has been firing a gun with lead-shot at the wall. These holes are too small to be from German machine-gun bullets, 7 or 13 mm in diameter, interpreted to account for the structures in Figs. 9 and 10. One type of missile which would have made small holes like these is a *flechette* or aerial dart, several cm (1 inch) to 10 cm (4") long (Fig. 15). They were used by the Germans in WW1, dropped in their 1000s from planes on to soldiers below, notably over the trenches of northern France, and by the US Air Force in the Vietnam war (so-called 'beehive bombs'); however, I cannot find reference to their use by the Luftwaffe in WW2.

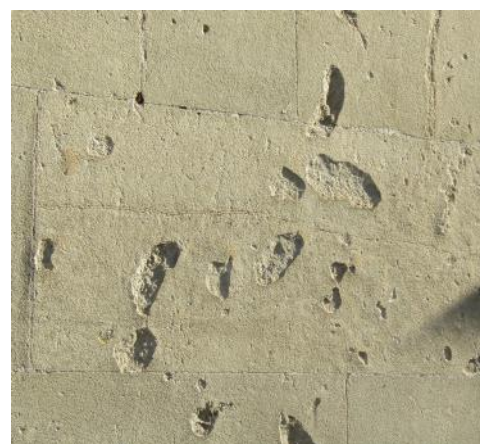
Fig. 10: Likely bullet gouge marks on Jane Austen's house, Gay Street.

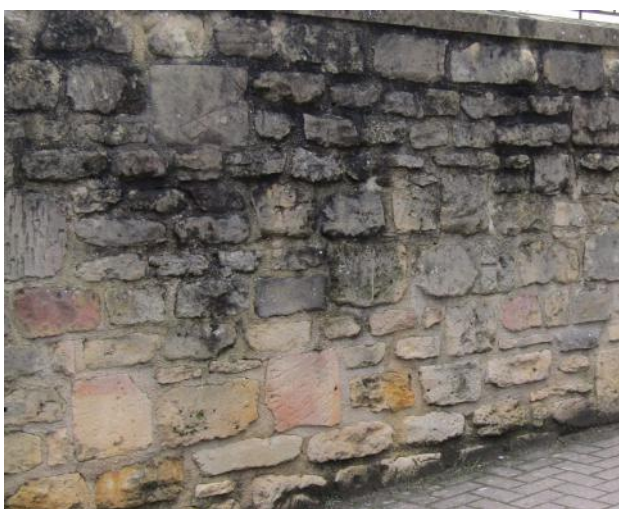
Fig. 11: Blocks of pink Bath Stone in a wall by Julian Road, likely coming from a nearby building which suffered fire damage.

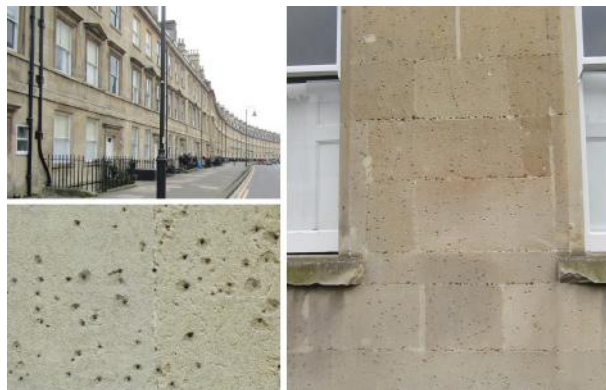
On quite a few buildings around Bath, easily seen in Queen Square (north and east sides) and in The Paragon on two houses (not far from where a 250 kg bomb landed and destroyed house numbers 28, 29 and 30), there are some intriguing structures that look very much like small impact marks (Fig. 12). They are mostly in the range of 10-20 mm in diameter. Some are clearly impact marks, like miniature shrapnel marks, where stone has flaked off to create a small crater. Some appear to be asymmetric, as if they formed from an object coming at an angle. In many cases these mini-crater-like structures, have a central hole of ~5 mm in diameter, and there may be a fragment of metal within the hole. The other nota-

ble feature is that these holes tend to occur in clusters, several or many 100s in the same area, covering a square metre to several m^2 . They mostly seem to occur on walls up to 1-3 metres above pavement level and between ground-floor windows, but they do also occur higher up, on first-second floor walls. These clusters are not particularly common across the city, although the more you look the more you find!

Fig. 12: The Paragon, a classic Georgian street in Bath, with an area of small impact holes, here many with a central hole, in some cases occupied by metal. Stone blocks 30 cm high.

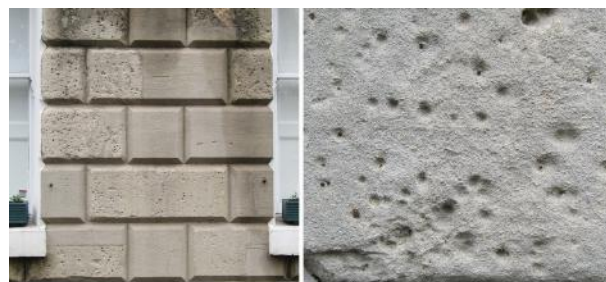
These small impact marks are also clearly visible on two houses in Walcot Parade, and a few buildings in Queen Square (notably in the SE corner, but also on the north side, east end) (Fig. 13). They can also be seen on some houses in the Royal Crescent and good examples are present in Bathwick Street (Fig. 14). They are present at first-floor level on the front wall of Magdalen Hospital (rebuilt 1761), in Holloway, near Beechen Cliff. Seven bombs landed around here, causing much damage, and 2 soldiers were killed by machine-gun fire. Somewhat similar ballistic impact marks are illustrated in Mol & Gomez-Heras (2017) from the School of Medicine of the Complutense University, Madrid, a site of action during the Spanish Civil War (1936-39).

Fig. 13: A wall in Queen Square with some new stone but numerous small impact marks on older stone, with a range of features.

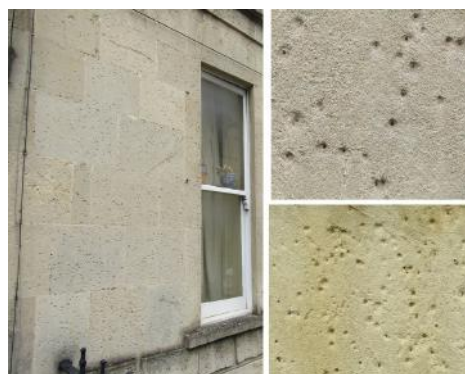
Fig. 14: A wall in Bathwick Street peppered with small impact marks, some with a central hole (+/- metal), others just a crater.

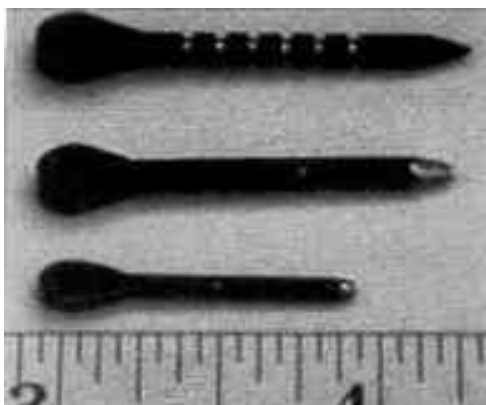
Fig. 15: Flechettes – aerial darts dropped by planes, are the correct size for the small impact marks with central holes. Scale inches. Image: Wikimedia Commons.

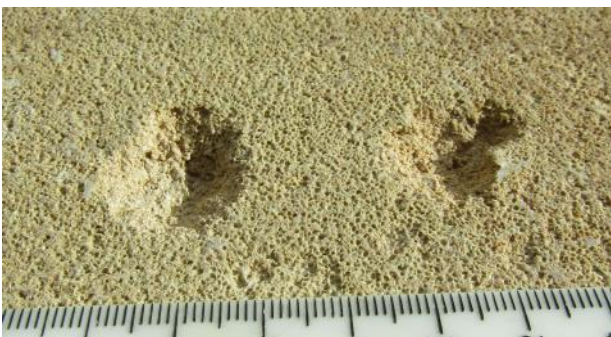
Fig. 16: Ballistic impact marks (scale in mm) in Bath Stone from an air-rifle using .177 calibre Webley VMX pellets from a distance of 2 metres. These mini-craters are similar to some of those on buildings in Bath.

As an experiment, and thanks to Graham Hickman's son's air-rifle, a few rounds of VMX pellets were fired

at some slabs of Bath Stone (Fig. 16). The ballistic impact marks produced are not very different from many of the small ones on the buildings in Bath. Since the gun was firing aero-dome head pellets rather than pointed pellets/bullets, there is no central indentation there. More elaborate experiments and measurements to determine the effects of bullets on stone have been reported by Mol et al. (2017) and Gilbert et al. (2019) using an AK47 on sandstone.

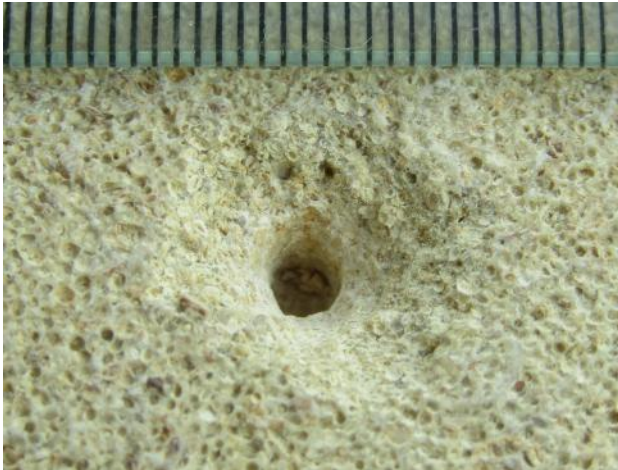
If the small impact marks are related to holding up a creeper, one might expect the holes to be better 'organised', occurring in a line or more regularly spaced out (perhaps to take a wire), rather than in their apparent random, scattered arrangement. However, hammering a masonry nail into Bath Stone does produce a hole very similar to some of those on Bath house walls (Fig. 18), and if a nail broke off or rusted away, there could be a bit of metal left in there.

Interesting, the effect of knocking a nail into the stone is to produce a powder which forms a coating inside the hole. And fragments of Bath Stone flake off during the hammering.

Fig. 18: Hole created from the impact of hammering a nail into a block of Bath Stone. Scale mm.

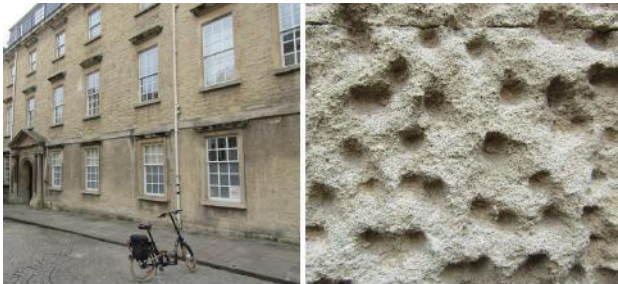
Finally, in terms of man-made holes in Bath Stone, the front walls of a few heritage buildings in Bath are patterned with ridges and hollows, or pitted by circular

chiselled or drilled holes of various sizes. These kinds of decoration are referred to as **vermiculation** (since reminiscent of worm burrows) and can be seen on the front of the Guildhall, built 1778, and the former bank at the top of Milsom Street (Devon et al. 2001). But there is one building where the front wall at ground floor level is covered in small pits of a similar size to those small impact marks that are a puzzle: The Hospital of St John the Baptist, built in 1727 by John Wood, the Elder (Fig. 19); in fact this was his first project, followed by the classical palladian-revival style of Queen Square (built 1728-36).

Fig. 19: Vermiculation on the wall of The Hospital of St John the Baptist.

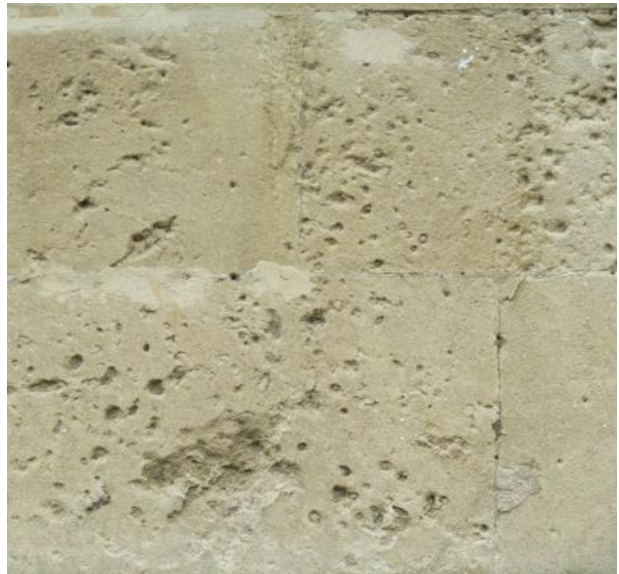
What other possible origins could there be for these holes? Are there any likely natural explanations? Some of these structures could be cross-sections through burrows. Bath Stone is an oolitic grainstone, a lime sand composed of ooids deposited in a shallow, moderate-energy sea, like the margins of the Bahama platform today, Joulter's Cay for example (Tucker et al. 2020). In such a location there would have been animals living within the sediment, annelids (worms), but especially crustaceans (like *Callianassa*), and there are definitely some burrows in the stone. Some of these burrows are lined, with slightly better cemented sand, and less well-cemented sand within the burrows themselves. On weathering of the burrows, holes are formed in the oolite, as in Fig. 20. Although a few of the holes could be burrows, this cannot be the explanation for all of them.

Fig. 20: Holes on a wall in Duke Street, likely to be the burrows of Jurassic crustaceans (or worms), i.e., bioturbation.

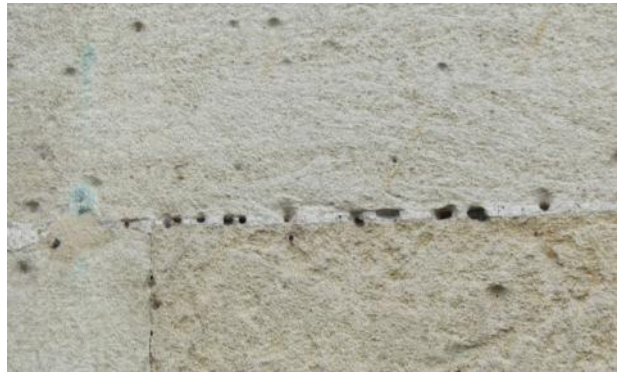
What about stone or masonry bees? Perhaps not although in a few places there are concentrations of holes in the mortar between the stone blocks (Fig. 21), so maybe some. Thus, in summary here, these small impact marks are a conundrum. Perhaps, like many features in

Fig. 21: Holes which could be from the activities of masonry bees. Or more nails for the clematis (or both)?
