## THE CATHEDRAL ROCKS – THE EARTH MATERIALS USED IN THE CONSTRUCTION OF SALISBURY CATHEDRAL

Field Meeting, Saturday, 31<sup>st</sup> March, led by Steve Hannath, Wiltshire Geology Group.

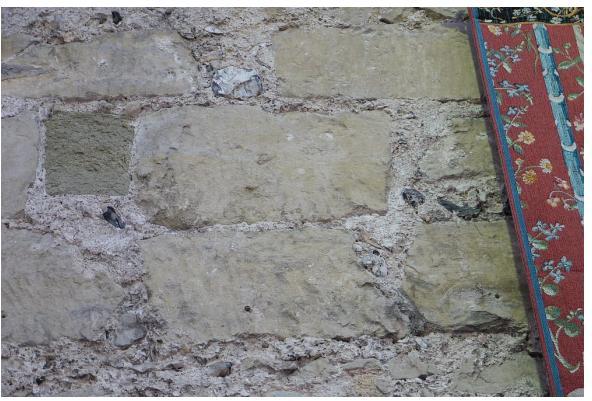
Hurdcott stone in wall of refectory restaurant

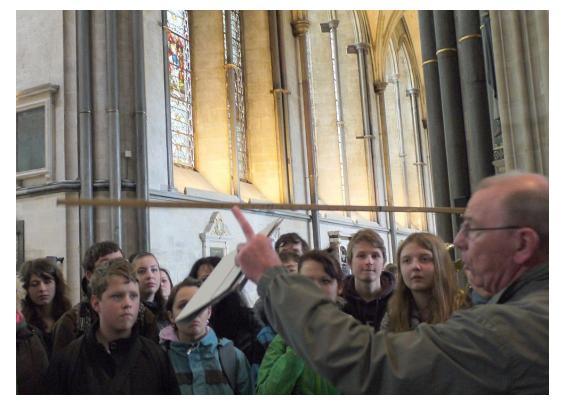
*Steve proves that there is water beneath our feet!*

was a depth of water there. This was thought to be some 15% of water by volume to the gravel, 9m in depth. Earlier he had claimed that the Cathedral floated and that that was the reason it still stood! There were built foundations, of course, as already indicated, but they did not go below the level of the summer water table. Those for the four main Purbeck marble columns at the Nave and Transepts Crossing that were eventually going to bear the weight of the added tower and spire being founded like all the others at a depth of just 1.2m. These four each exert a force of approximately164 tonnes per square metre on the hard, well-sorted gravel terrace.

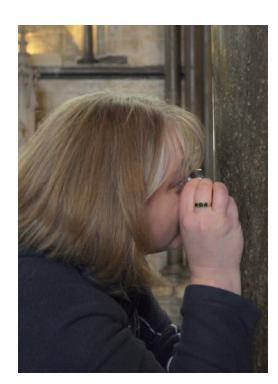
Mell gets close to Viviparus

Purbeck marble has also been used as flooring at Salisbury where some 15,000 tons were laid down. Particularly where polished, fossils of the Viviparus genus of freshwater snail together with fossils of the larger genus Unio, may be clearly seen, both in the slender

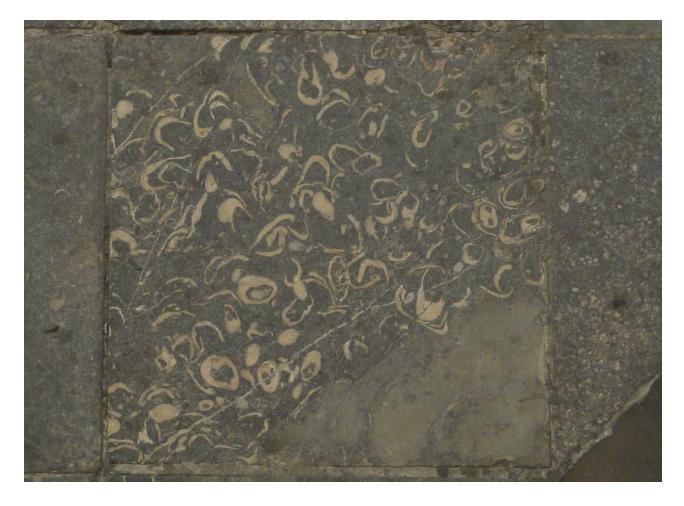
Fossils of the genus Unio in Purbeck marble flooring

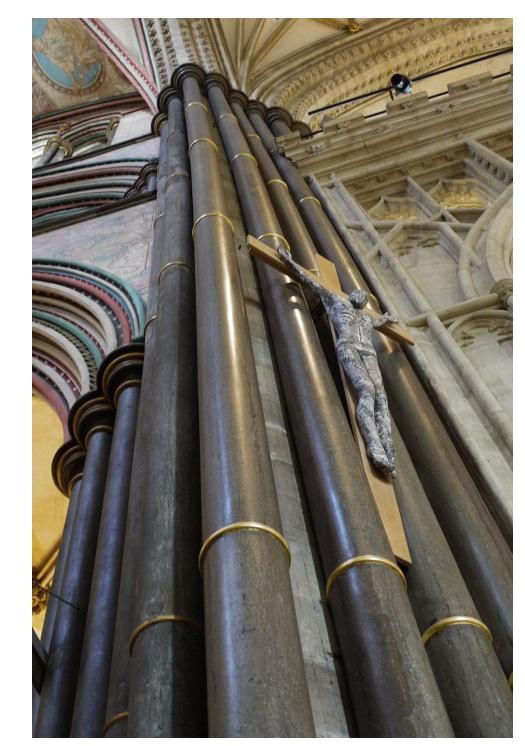
Purbeck marble columns appear to bend

Purbeck limestone at the Crossing, particularly at the North-West corner where five sections of the slender decorative "marble" lengths

appear to bend out at the top (some 60cm to the South-West) although they are not, in themselves, bearing any weight. It would be more accurate to say that they have slipped out of true or become displaced. It should be mentioned here that the limestone that was

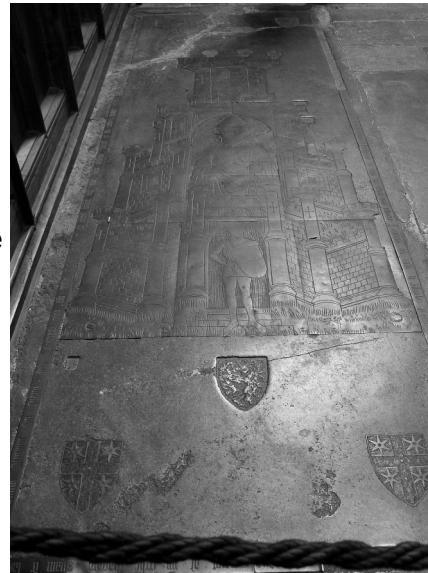
Perhaps the largest slab of Purbeck marble in the world

destined to become the polished Purbeck marble columnar lengths was quarried from beds horizontally in order to achieve this. The largest slab of Purbeck marble in the world, according to Steve's account, is to be found in the Morning Chapel and is laid into the floor as a monument to Bishop Wyeville who became bishop at about the same time as the spire was completed. It measures approximately 3.90m x 1.40m although it was damaged, probably during a move, and now bears evidence of a repair. Steve mentioned that

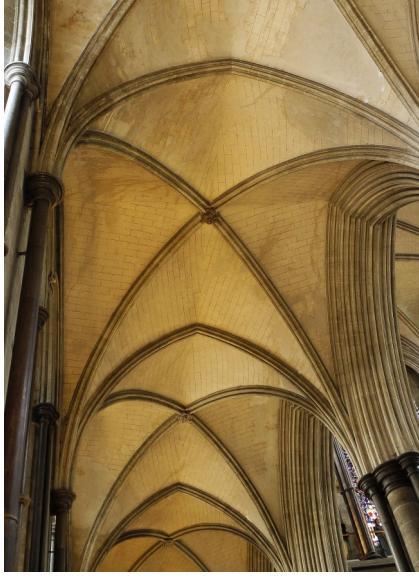
Quadripartite fans built with calcareous tufa

The pointed arch was used exclusively in the vaulting of this Early English Gothic period and Calcareous tufa or calc. tufa, a soft porous rock of precipitated limestone formed in a similar way to stalactites and stalagmites and probably from Somerset, was used in the construction of the quadripartite fans at Salisbury. It was plastered from below and decorated in such a way that the design appears to be brick and it

was plastered from above as may be seen by anyone taking the Tower Tour so that the calc.tufa is effectively sealed in and hidden. However, it was not exclusively used for this purpose and Steve mentioned that even brick was sometimes used. In the 15<sup>th</sup> Century, the beautiful lierne vault of the Decorated Period replaced the wooden ceiling at the Crossing and records show that the Hazelbury stone for the ribs was brought from the Box area and was also used for the new flying buttresses at the North-East corner of the tower. Bath stone was used for the 16<sup>th</sup> Century Audley Chapel. Another oddity is the Lepine limestone from near Poitiers that had been used as a substitute for Caen stone and may still be seen.
